DENVER, COLORADO
SHEET 1 OF 1

2010-04-07
449-D-1638

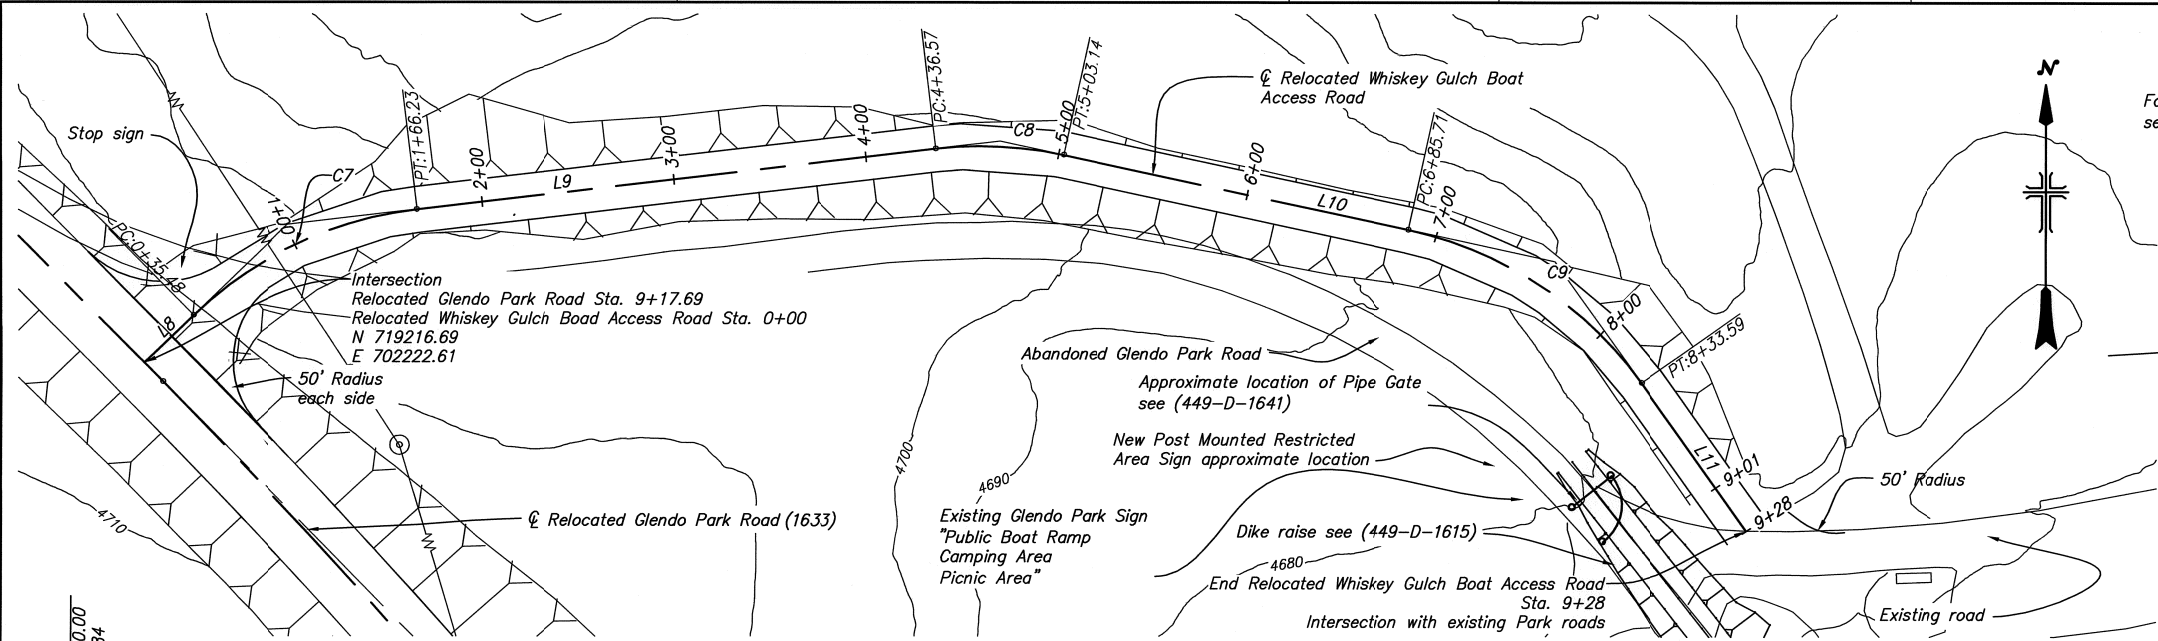
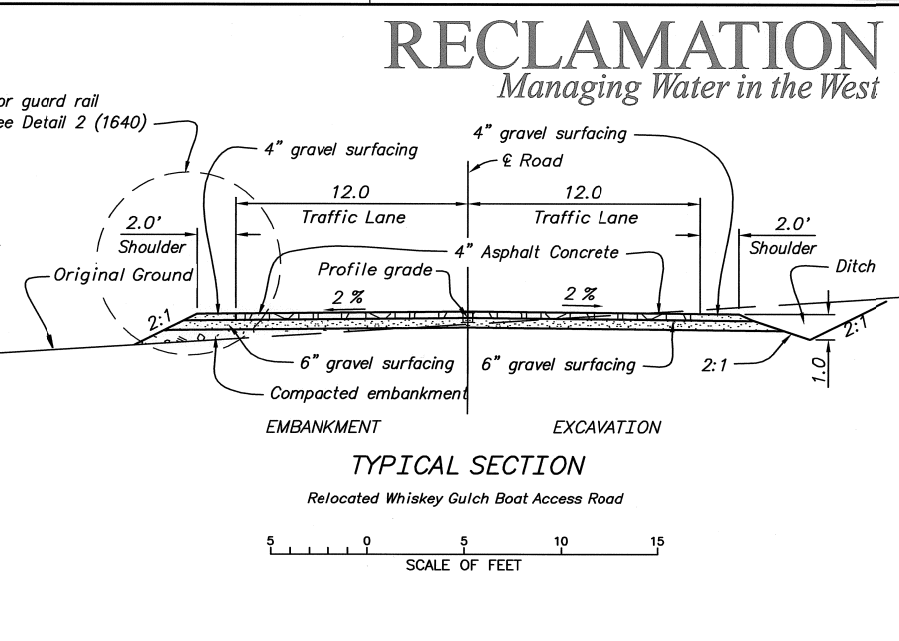
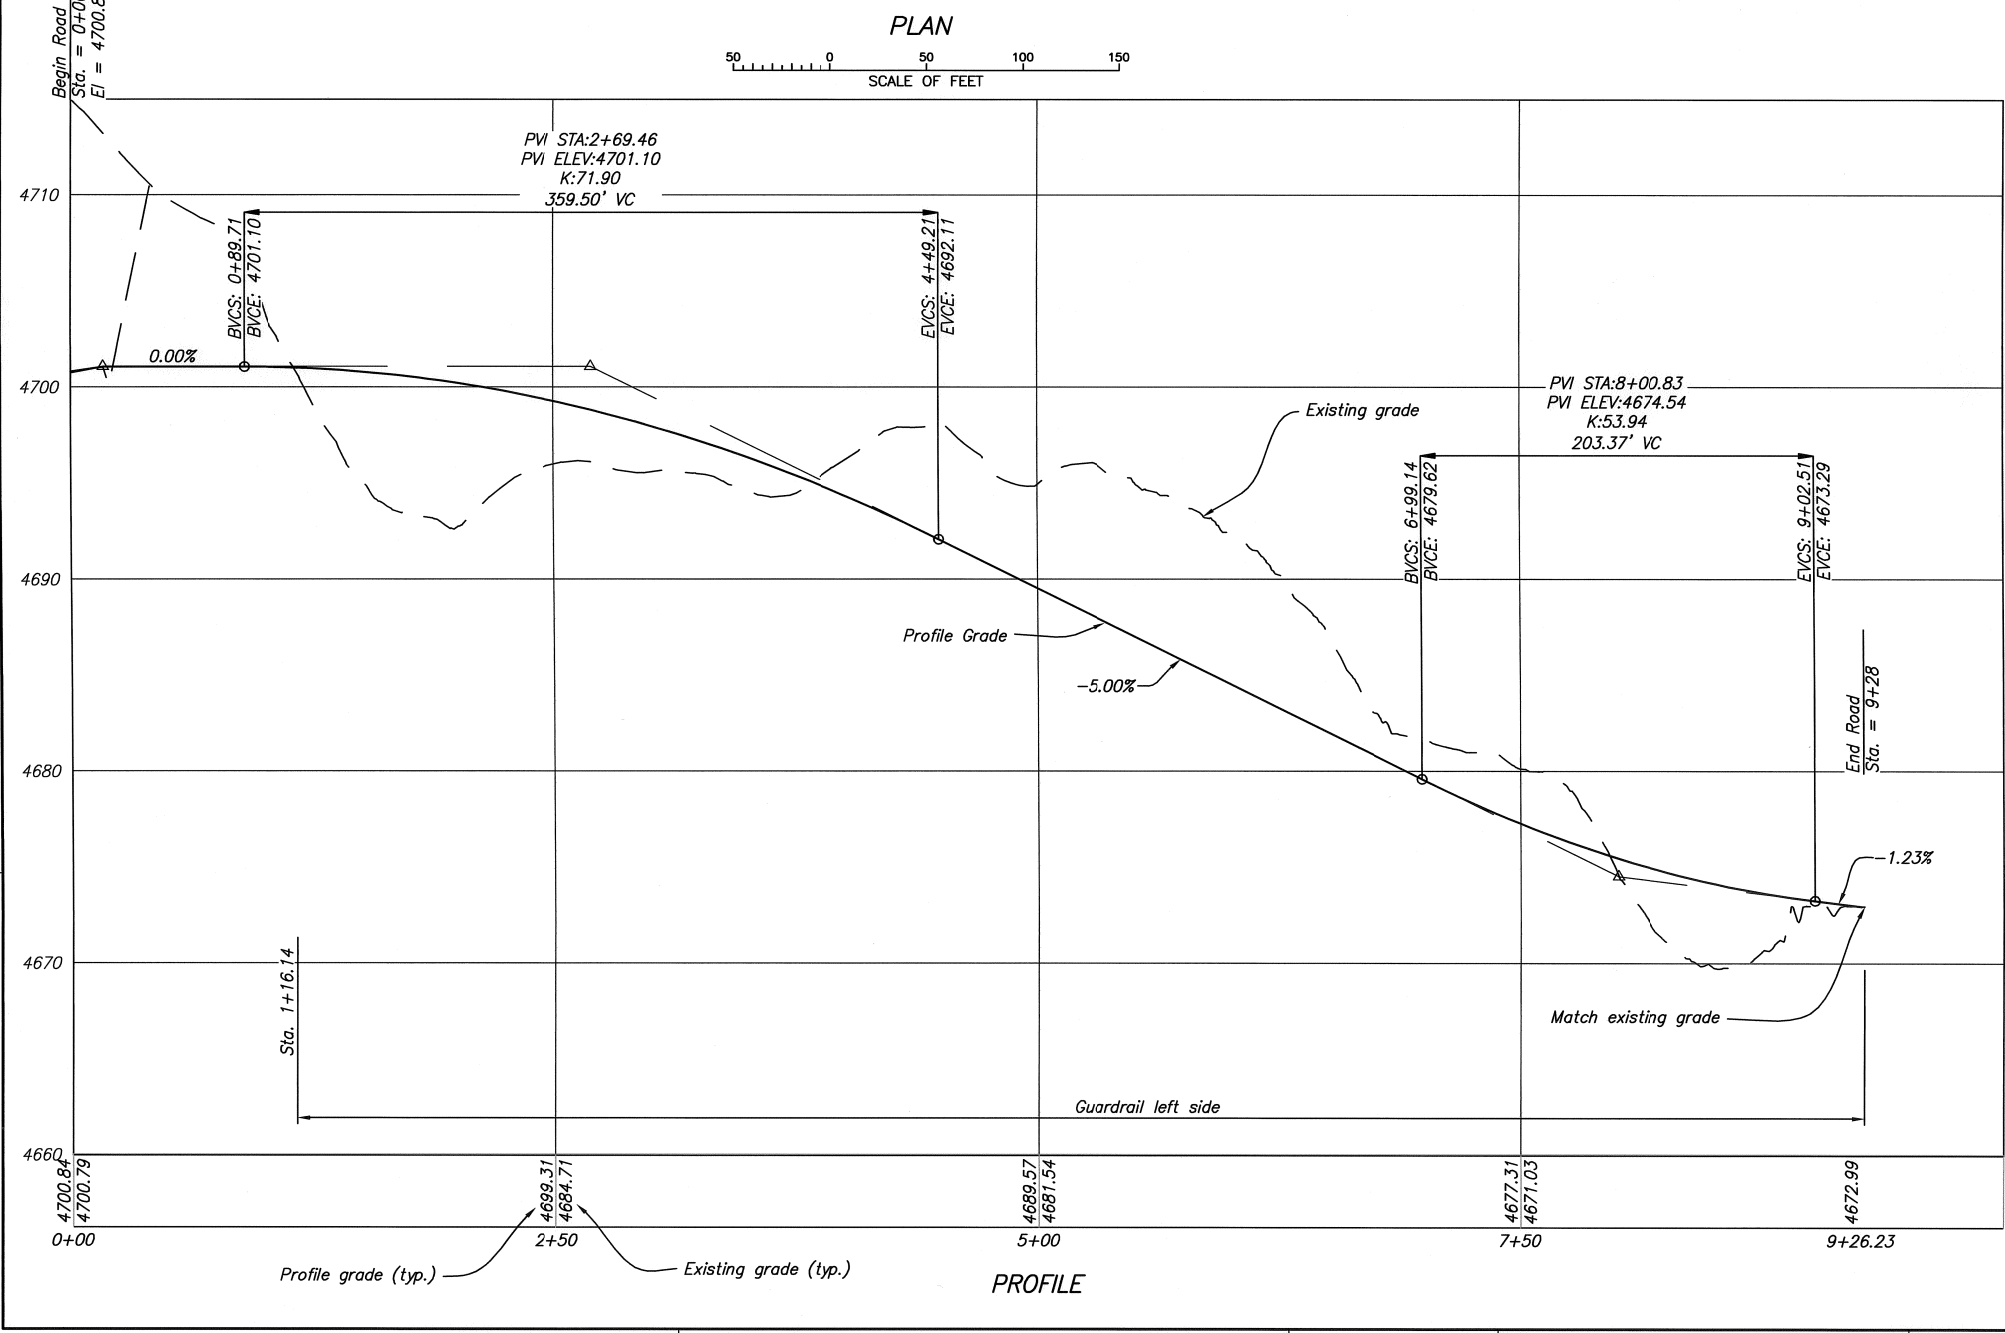
| Curve Table | | | | | | | | |
| Curve | Length | Radius | Delta | Tangent | Chord | PI | PC | PT |
| C7 | 130.75 | 200.06 | 37°26'43" | 67.80 | 128.43 | 1+03.29 | 0+35.48 | 1+66.23 |
| C8 | 66.57 | 200.06 | 19°04'00" | 33.60 | 66.27 | 4+70.17 | 4+36.57 | 5+03.14 |
| C9 | 147.88 | 200.06 | 42°21'07" | 77.50 | 144.53 | 7+63.21 | 6+85.71 | 8+33.59 |

| Line Table | | | | | | |
| Line # | Length | Bearing | Start Northing | Start Easting | End Northing | End Easting |
| L8 | 35.48 | N45° 48' 12.55"E | 719216.69 | 702222.61 | 719241.41 | 702248.05 |
| L9 | 270.34 | N83° 14' 55.33"E | 719296.64 | 702363.96 | 719328.41 | 702632.35 |
| L10 | 182.57 | S77° 41' 04.81"E | 719325.19 | 702698.52 | 719286.26 | 702876.83 |
| L11 | 94.51 | S35° 19' 57.57"E | 719206.53 | 702997.34 | 719129.45 | 703051.98 |
